INSPECTION TRENDS

Inspection Program for a Light Rail Bridge

A short fabrication time and complex T-Y-K joints presented challenges during construction and inspection of a steel tubular bridge

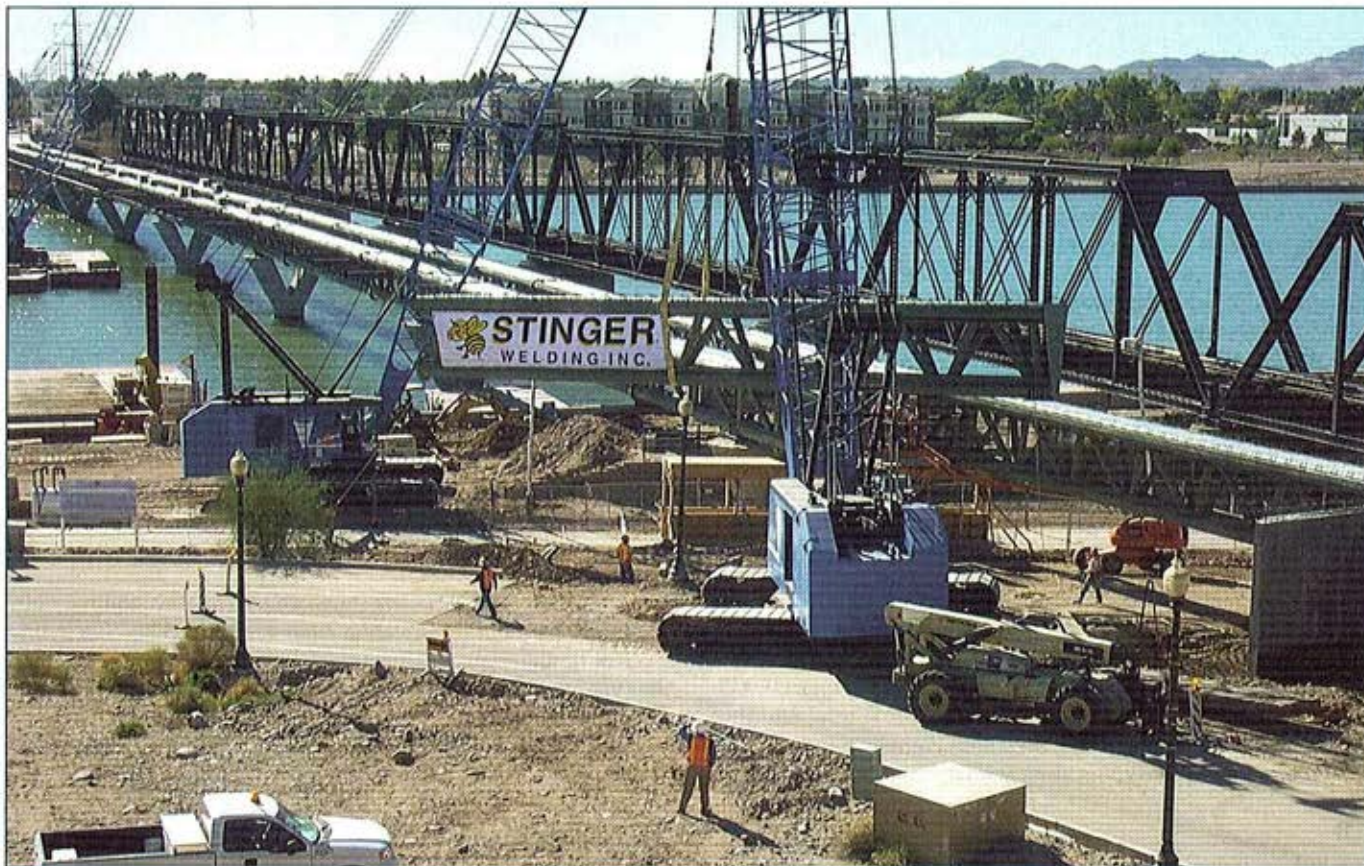
Fig. 1 — The bridge services the Phoenix, Ariz., light rail network and spans Tempe Town Lake. Here the last segment is being hoisted for setting at the northeast abutment. At right, parallel to the new bridge, is the historic 1912 single-track truss bridge that is still in use.

A recent challenge for Stinger Welding, Coolidge, Ariz., was fabrication of a steel tube-structure bridge to link the Phoenix, Ariz., light rail network with the east-valley communities across Tempe Town Lake (a section of the normally dry Salt River contained by upstream and downstream inflatable dams) — Fig. 1.

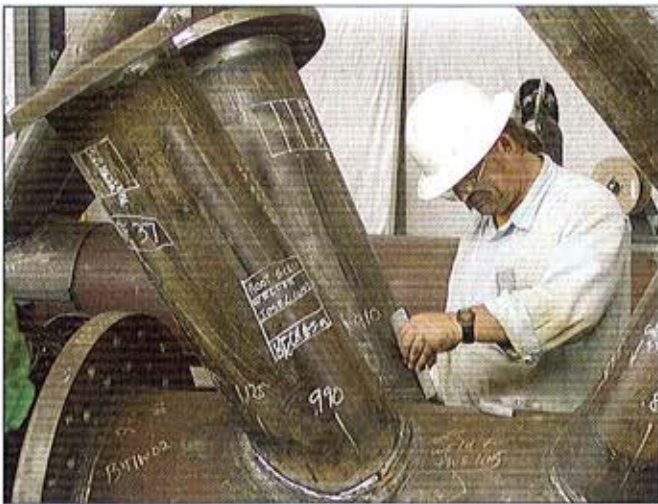
Fig. 4 — UT technician and CWI Dennis McNamara verifying depth of groove after grinding a root pass.

Conventional weld gauges were of little use. Simple go/no-go depth gauges and the equivalent of fillet gauges were fabricated and calibrated in-house for quick, accurate, repeatable weld measurements — Fig. 4.

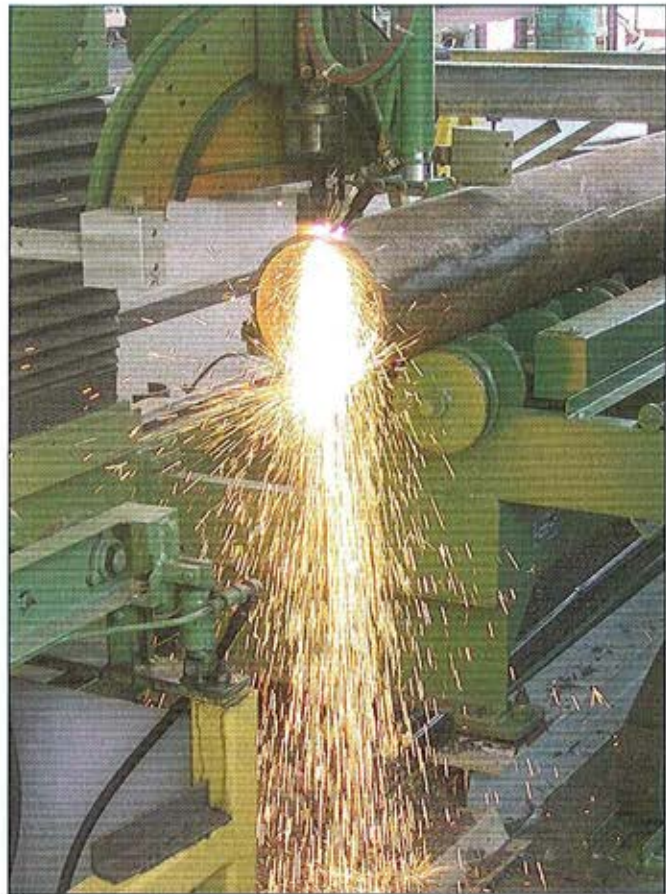
Fig. 5 — End of thin-wall diagonal member being thermally cut on CNC equipment. The length, end-for-end clocking, asymmetric "fish-mouths," and bevel angle are simultaneously cut.

The diagonals were too complex to be manually cut, so specialized CAD software, a firmware interface, and CNC thermal cutting equipment were integrated. This system simultaneously cut and rotationally aligned the asymmetric "fish-mouth" on each end within 0.5 deg, beveled the included welding angle, and cut each diagonal to length with the allowance for root openings within 0.05-in. tolerance — Fig. 5. Fabricating this struc-

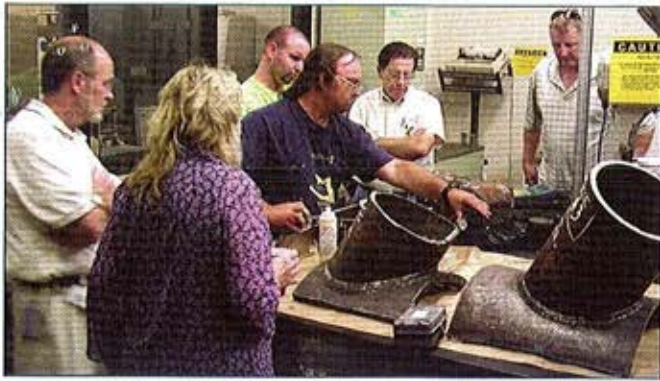
Fig. 6 — Evaluations of test coupons having known defects to develop and validate UT procedure. Witnesses include VMR QA, Level III technicians from both VMR's and Stinger's independent contract inspection services, and Level II inspectors involved in the procedure development.

D1.1 Section 6.27 specifies the minimum requirements for UT of T-Y-K joints, 6.27.1 specifies the procedural requirements, and 6.27.2 specifies requirements for technicians. Five joint coupons, with and without defects, were welded and evaluated to satisfy all parties that a testing procedure was as follows:

- ◆ Effective in finding and sizing real-world defects in all joint configurations;
- ◆ Effective in eliminating false indications, which would create unnecessary rework and potentially degrade the reliability of the structure; and
- ◆ Able to be performed effectively and repeatedly by adequately trained and tested personnel — Fig. 6.

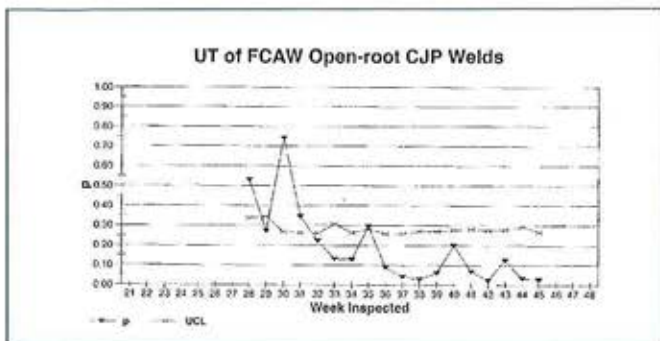
Fig. 8 — A “p” chart showing a statistical analysis of the number of welds initially inspected (first-pass inspection, submitted to UT just after cooling) that showed a UT indication. The upper control limit (UCL) is statistically derived from the number of welds inspected. The lower control limit (LCL) is not shown since it is meaningless in this application (zero is the effective LCL). Whether or not the “p” values lie within the control limits indicate whether a process is in control or not in control. The unusually high level of indications early on represents both indications as well as geometric reflections. P values, and therefore rework, fell off rapidly as experience was gained in both welding and UT inspection.

A pattern in the location of UT indications was quickly noticed, and the validity of the UT procedure became suspect. Nearly every joint exhibited apparently large defects at its most easily welded area. During “exploratory surgery” of several of these indications (careful carbon-arc gouging), no inclusions of any kind were found. Ultrasonic testing technician Stephen Tekoseno (Fig. 7), who was brought in from offshore oil rig territory for this project, applied some by-the-book theory, performed some calculations, drew some sketches, and determined the cause of the nonexistent indications, which turned out to be geometric reflections. He then trained the other UT techs, including Valley Metro’s contract Level III technician, in interpreting and eliminating what, in fact, was a nonproblem — Fig. 8.
